15 Things you never want to see on a yacht

Boat surveys can reveal all sorts of horrors. Ali Wood learns about some of the worst from marine surveyor Ben Sutcliffe-Davies

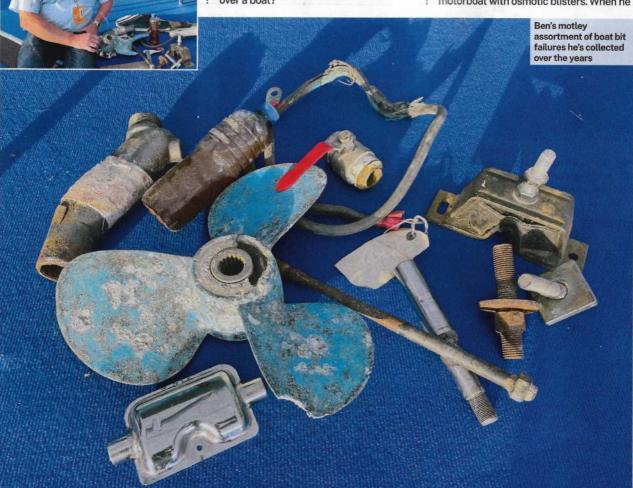
"You are less likely to see osmosis on modern production boats because of the types of resins used," says Ben. "Older boats use basic polyester resin and the chopped strand mat, that has endfilaments, soak up water for years".

Ben recently surveyed a 1980s motorboat with osmotic blisters. When he

blisters were so severe that the only solution would be to have the boat fully peeled, hot-vacced, and given at least two or three coats of laminate, at a cost of £30,000... plus months of drying time.

Although a blistery hull might not seem all that bad at first, the high moisture will make the laminate soften, which could result in the boat sinking. Ben has seen hulls that are so soggy they slump over the strops when lifted out and the keel flexes easily.

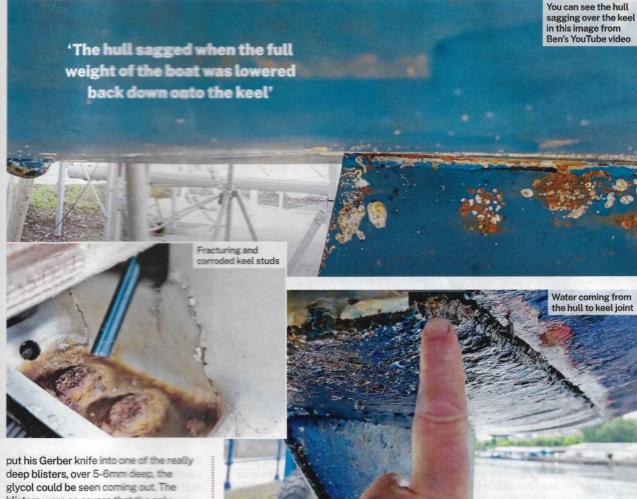
The floor of this yacht

has buckled due to pressure from the keel

during grounding

Grounding damage can also be spotted inside the boat. In the previous example, an inspection of the internal keel matrix revealed all sorts of red flags such as corroded keel studs, gel coat crazing and fracturing on the foot of the compression post. Ben also noted signs of buckling and hogging-where the front and aft of the boat are lower in the water than the middle. The impact was so severe that it separated the internal pan moulding away from the hull which was obvious around the seacock fittings.

As well as removal and repair of the keel, the whole matrix will need to be cut out, repaired and glassed back in, depending on severity.

"If your boat's grounded, replace the keel bolts too," advises Ben. "Don't re-use them, even if they look OK. Roll them across the table and you'll soon see they're not!"

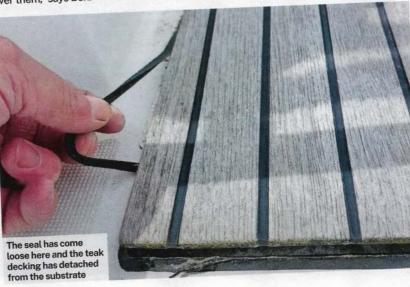
LEFT Water ingress to a balsa core deck. Not a good sign if you can flex it easily with your hand!

"I'm not a great fan of balsa core decks," he says. "When you get water into the decks the whole deck pumps up and down. So how can we solve this? Remove the balsa core from the internals and reinforce with suitable pads from the underside glassed in."

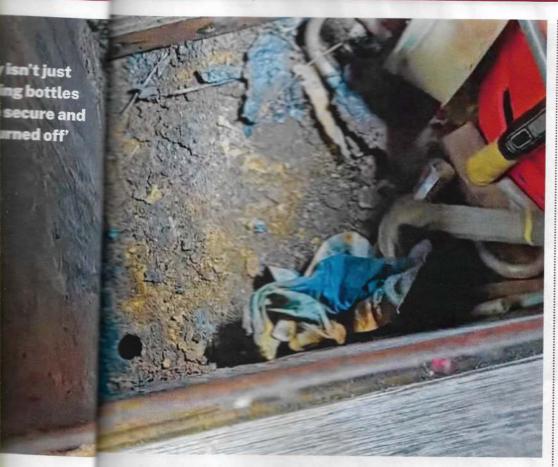
In steel gas lockers, be aware of corrosion which you can test by a small knock with a hammer. In one particular boat, the gas safety certificate was obtained just months earlier but the base plate was badly rusted over and crumbling.

"If I hit that with a hammer it would go straight through," says Ben. "The gas compartment is over the engine, where you've got an alternator, a starter motor... if the gas leaks you'll have an inland waterway bomb. Please check your gas locker. It's simple!"

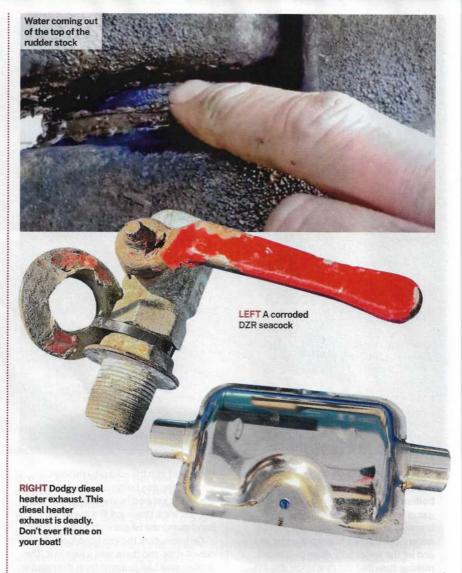
"The exhaust is a big part of the problem," he says. "There's a press metal fitting which isn't airtight and a hole at the bottom for when it's fitted to a truck so that any water vapour can simply drop out the hole. In a yacht, any vapour that drops out is going to be carbon monoxide or exhaust gases which gather in the bilges."

On his YouTube channel, Ben demonstrates just how bad the unit is by sealing it with a bung and pouring water in

through the other side. The water drips everywhere!

"If you buy a boat, look at the exhaust system and make sure you don't have one of these fitted," he says, referring to a part he sourced from China. "Get rid of it, buy yourself a proper one that is suitable for marine use."

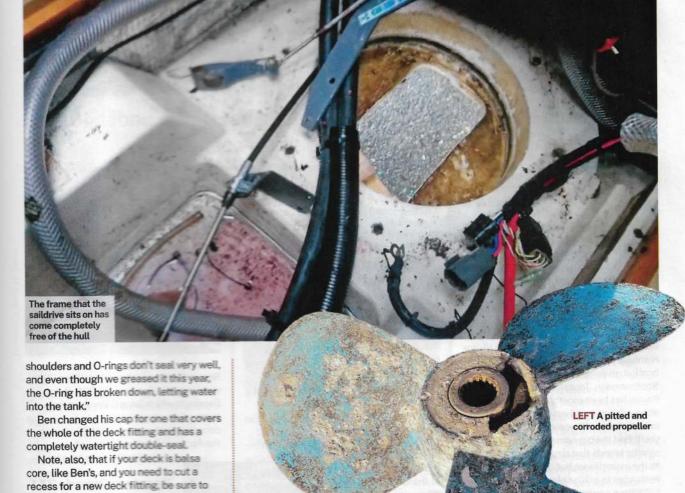
Ben cites a 5-year-old powerboat he surveyed with twin engines and propellers. One propeller was correctly bonded to the anode, which had all but disappeared, but on the other side the anode had been painted over with antifoul so wasn't doing its job.

Ben used his ball-pein hammer on both props. The correctly bonded propeller blade had a nice ring to it -it sounded high-pitched and tuneful and looked to be in good shape. The one that wasn't properly bonded was, in Ben's words, "As dead as dead can be." The hammer sounded dull and hollow and the tips of the blade had even broken away where he hit them.

has suffered completely from dezincification" he says. "I could even see the alloy pinking in the metal."

"That's total proof that this propeller
