Confessions of a maintenance dodger...

Some cruises start well then deteriorate, some start badly and get better. David Berry recalls a cruise that started badly... then got worse

David and Ann Berry keep their Moody Eclipse Aderyn Glas in Greece

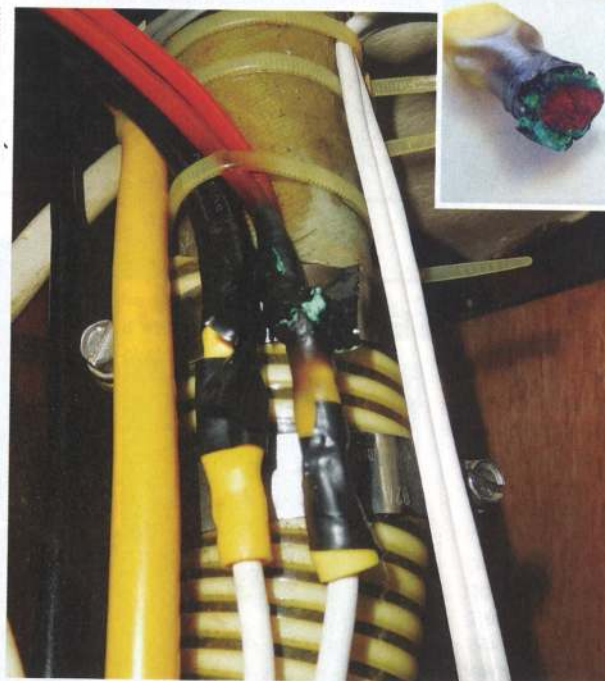
After some head scratching I disconnected the wire at the junction box near the panels then ran a separate one from the junction box to the controller and suddenly had loads of power. It was some weeks before I could investigate further then I found the corroded joint.

ABOVE The turquoise copper oxide colour was a giveaway! This was the likely source of the high resistance that was providing a voltage measurement but preventing any current getting to the controller

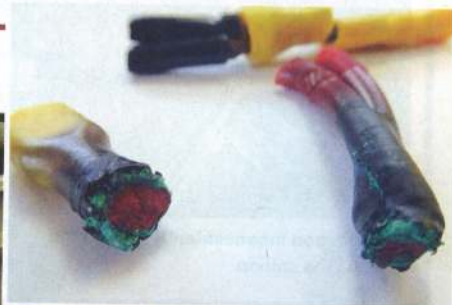
ABOVE In close up the oxide around the crimped connectors was evident. This connection was behind a locker in the aft cabin of the boat and should have been dry. Certainly there was no direct water spray onto the joint under any conditions so I had to conclude this was simply the result of 11 years in a salt-laden environment

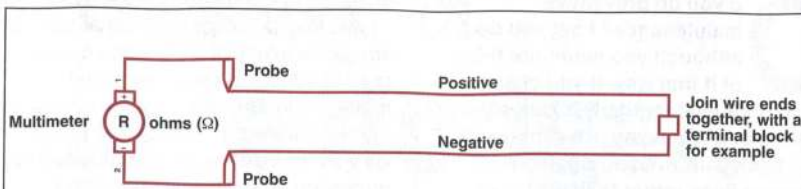
Loop resistance test

Loop resistance measurement. Any number of cores can be joined together as long as the measurement is taken between every pair

- 1) There must be no devices in the circuit
- 2) Connect together the wires to be measured at one end
- 3) Set your multimeter on a low value resistance scale
- 4) Connect the meter to the other end of the wire to be measured
- 5) The value of resistance is now the loop resistance

measurement. So once I'd repaired the joint I took a loop resistance measurement. This is done by simply joining the wire cores together at one end of the loop (as many cores as you have can all be joined together, in this case there were only two), then measuring the resistance between each pair of cores and noting the results – in our case 2.5Ω (ohms). Every season or so I shall check the resistance of the loop and compare it to the baseline.

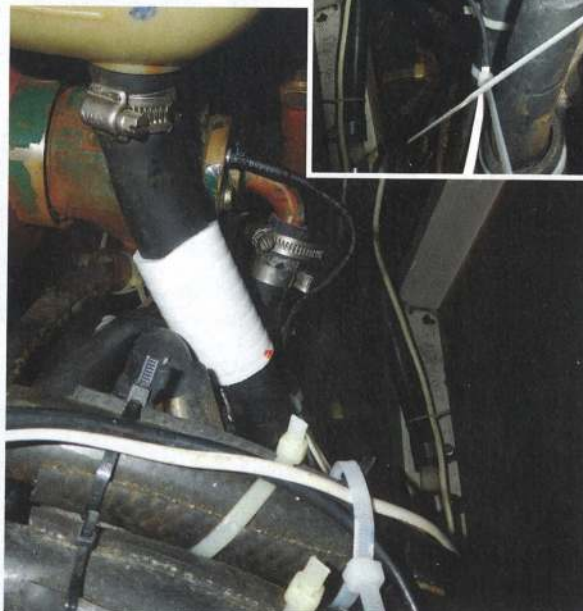
So it was with the greatest of irony we discovered that the tail end of a cable tie holding one of these protectors had cut into the feed hose from the header tank.

ABOVE A nasty case of cable ties cutting into the outer casing of the header tank feed hose

Pretty obviously the idea of sacrificial pads is sound. But each season the interfacing pads should be examined at all the locations in the engine where hoses rub and they should be replaced when necessary.

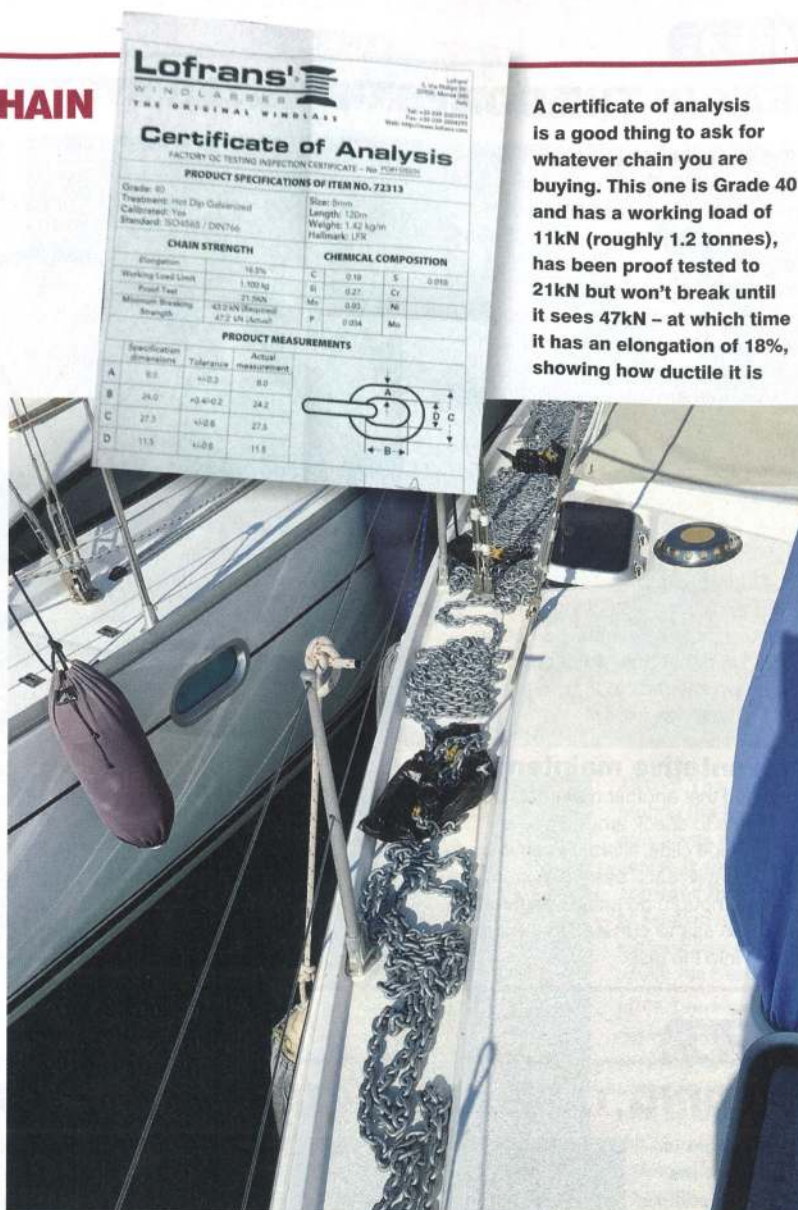
I have never heard of an anchor chain breaking nor has anyone I've spoken to. We were reversing into a quayside when we heard a loud bang. Ann, on the foredeck, pulled on the chain with the windlass expecting to dig the anchor in and was a little surprised to find the broken end of the chain coming out of the sea onto the foredeck.

Seeking advice from an expert I contacted Vyv Cox, well known contributor on the subject of mechanical engineering, chain and anchoring in general (coxeng.co.uk/anchoring/chain). Vyv was as surprised as I was that a chain which should have been ductile had somehow become embrittled. Unfortunately the broken link was lost in the mud at the bottom of the harbour so we could not rescue it for analysis.

This is the old chain which, on the face of it, doesn't seem in too bad a condition. It was less than five years old, still well galvanised which all implies a source manufacturing problem. It was supposed to be of reliable Italian manufacture, but we now have some doubts

Out with the old and in with the new. Our 60m of new galvanised chain from Lofrans is stamped with their hallmark every few links. At the same time I replaced the swivel that joins chain to anchor

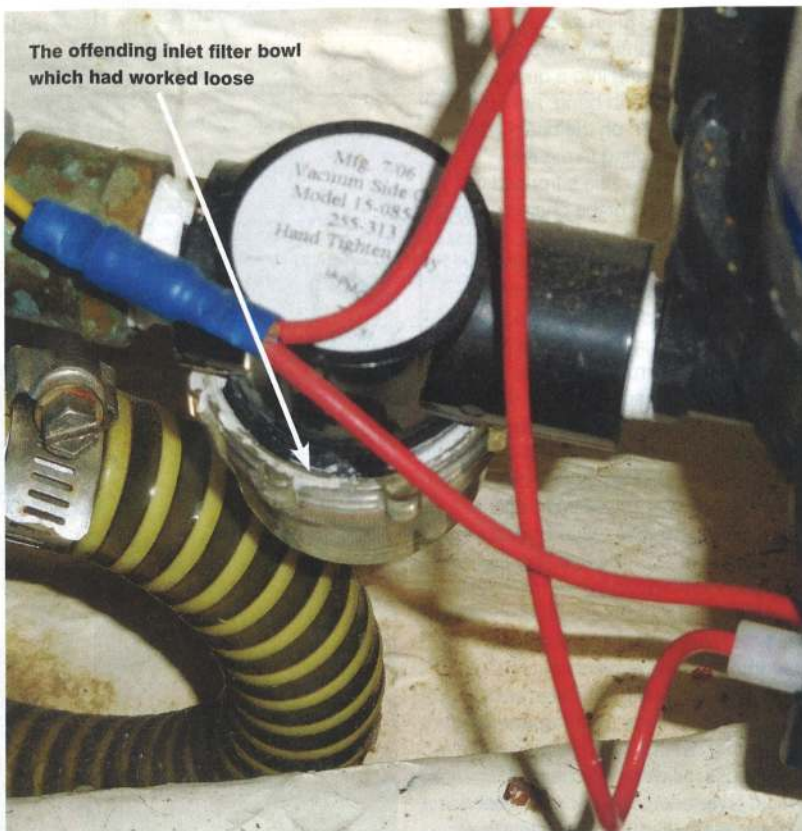
Anyway, this was not salty so we were not sinking. Then I had my head in the bilge for some reason when Ann turned the tap on and there it was – a steady drip as the pressurised water system ran. Oddly the drip was from the filter on the inlet, suction, side of the pump which ought to have meant air being sucked in rather than water pouring out. It took two seconds to tighten the bowl and the leak was fixed.

The offending inlet filter bowl which had worked loose

I decided that another maintenance task should be to check around all the fittings, pipe clips, filters and anything else of that ilk each season. A word of warning though: do not over-tighten pipe clips as this can lead to the clip cutting into the pipe.

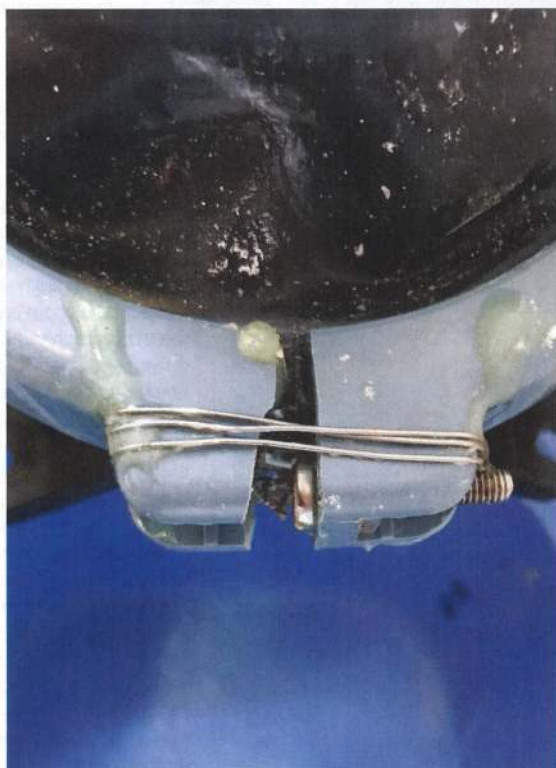
Everyone's worst nightmare: the clamp ring that secures the holding tank pump diaphragm in place had broken.

When I investigated I discovered the plastic had come from the part of the clamp where the screw and nut that pull the clamp together were housed. Now there was nothing to stop the clamp, and then the diaphragm, from falling off.

RIGHT My get-us-home fix for the diaphragm pump's broken plastic clamp ring meant taking some stainless mousing wire and making three individual wraps around the broken fixing then holding the wire on the slippery surface with a few blobs of epoxy

Pretty obviously the pump was long overdue for swapping out. We'd fitted this pump ten years previously and did not even carry a spares set for it. What's more I'd changed the ball valve which the pump was connected to and not thought for one moment of changing the pump itself. I guess I deserved every drop of brown stuff I had to clear up! It's now on the schedule for replacement after five years.

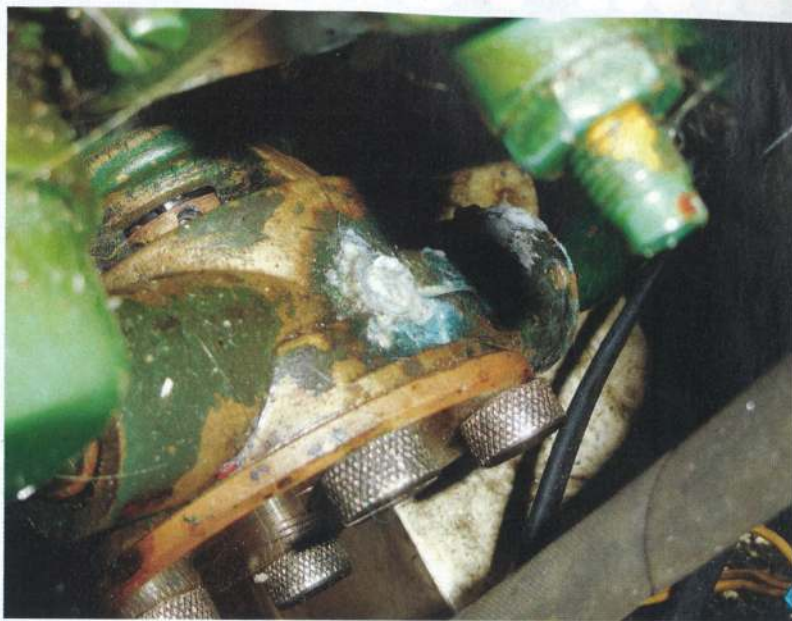
In our search for a saltwater leak (see Case 7, below) we discovered the screw securing the cam plate on the raw water pump had corroded away and was weeping slightly.

I had noticed when I replaced the pump seals (see PBO March 2018) that the screw was brass and was already showing signs of dezincification – it was turning pink – and I should really have replaced it there and then with a stainless steel screw. Failure of the brass screw could have resulted in the cam coming loose and the pump packing up.

ABOVE The whitish blob in the top of the pump was once a screw. It was so well corroded that trying to remove it with a screwdriver simply broke the head off

The only way to properly solve the issue would be to remove the pump from the engine, drill out the corroded screw and re-tap the thread ready to accept a new stainless steel screw.

Obviously I should have replaced the screw when I first saw it was suffering from dezincification.
