# Replacing a cylinder head and servicing injectors

Geoff Higginbottom rebuilds his engine with a new cylinder head while Stu Davies demonstrates a DIY injector service

**PART  
2**

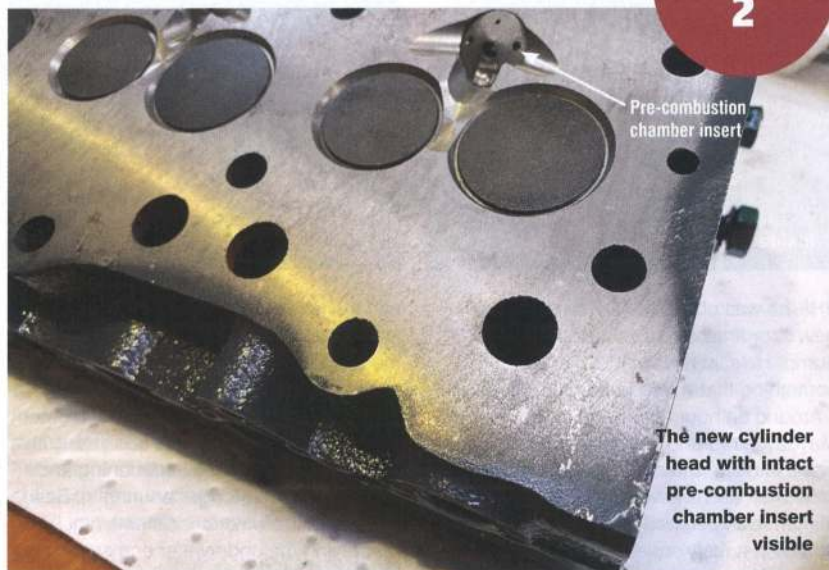
Pre-combustion chamber insert

The new cylinder head with intact pre-combustion chamber insert visible

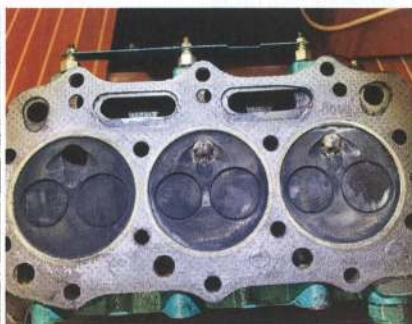
Geoff discovered a failure in the pre-combustion chamber in the aft-most cylinder, which led him to spend £1,200 on a brand new Perkins head (although Volvo insists its heads are machined differently to Perkins' the fact remains the engine started out life as a Perkins). The Volvo version would have cost 20% more; only time will tell whether that would have been money well spent...

What we might never find out is what caused the engine failure in the first place. Stu suggests: "The MD2030 has a bit of a reputation of the No3 cylinder having problems. It is the one nearest the exhaust raw water injection point and if any

blockage of the exhaust or failure of the anti-siphon valve occurs sea water gets back to that cylinder and starts to cause problems like Geoff has suffered. I'd suggest that he checks his anti-siphon valve to make sure it hasn't stuck!"

LEFT Geoff's Bavaria 39 Tessa Jane ABOVE RIGHT The precombustion chamber insert on the left cylinder has completely disappeared

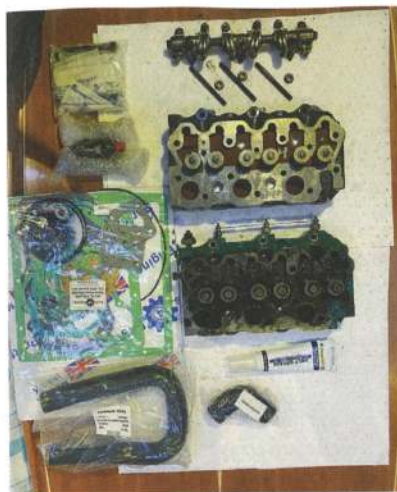
**1** Here are the old and new heads complete with new valves, new head bolts, a full gasket kit, new cooling hoses, serviced injectors with new nozzles, Molybdenum Disulphide grease which is required when fitting the head bolts, and the original valve rocker gear.

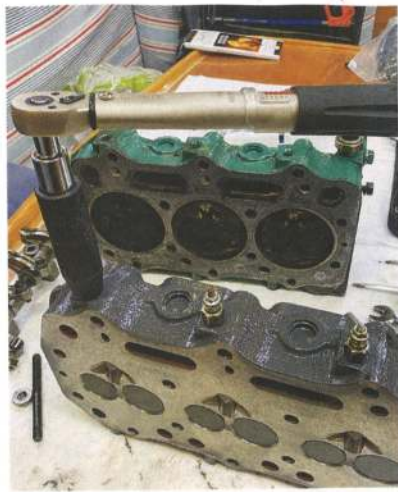
**2** The glow plugs needed to be transferred from the old cylinder head to the new one, and fitted using the correct torque – which is actually quite low and outside the range of my large torque wrench so this small wrench came in very useful.

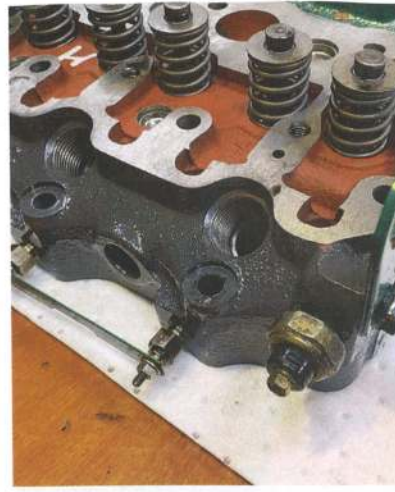
**3** With the glow plugs and their tie bar installed, the oil pressure sender, oil pipe hollow screw and lifting eye were also transferred and tightened to their specified torque. The new head came already installed with its new lapped-in valves and springs.

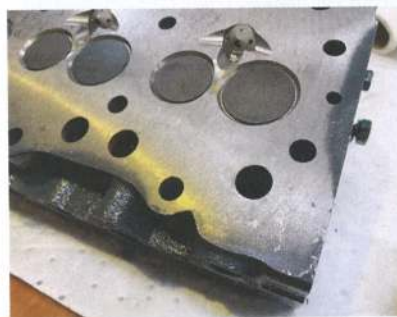
**4** Perkins had been a bit slap dash with their painting and there was overspray on the head mating surfaces which needed to be cleaned off. Not having a chemical paint stripper to hand, and concerned it may damage the surface anyway, I used very fine wet and dry to carefully clean all the paint off, going down to 2000 grit to leave a perfect finish.

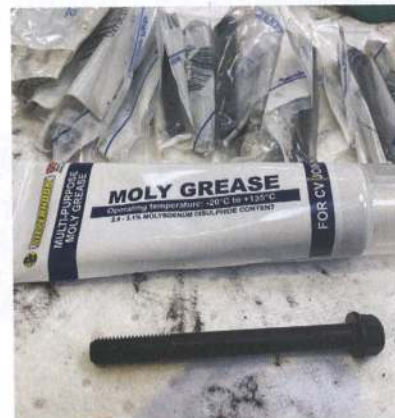
**6** The new head bolts were then lightly greased and fitted finger tight. There are three bolts that are shorter than the rest, and these are located adjacent to the injector ports.

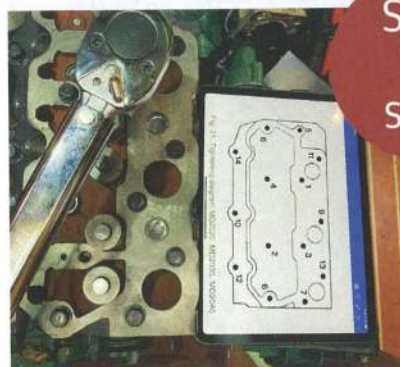
**7** Having the maintenance manual to hand showed the correct tightening order. Unlike old car engines I have worked on, there was no final tightening by x degrees, just a final torque setting given, so I tightened them in three stages to reach their final torque setting.

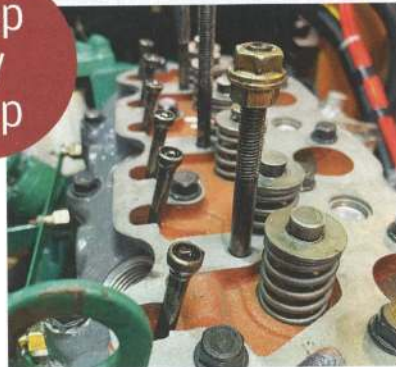
**8** With the head now firmly in place the push rods could be inserted and the studs which hold both the valve gear and valve cover installed, using two of the nuts to tighten them. The valve caps were also transferred from the old head as the new valves did not have any fitted.

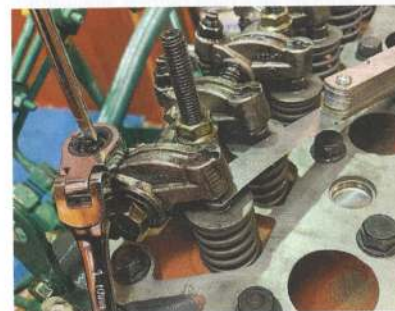
**9** The valve gear was then fitted, and a long reach socket used to tighten them to the correct torque, before adjusting the valve clearances. Using a ring spanner was a big help as you really need three hands to hold the spanner, the screwdriver and the feeler gauges. I'll need to re check them after the engine has had time to bed in the new valves. ➔

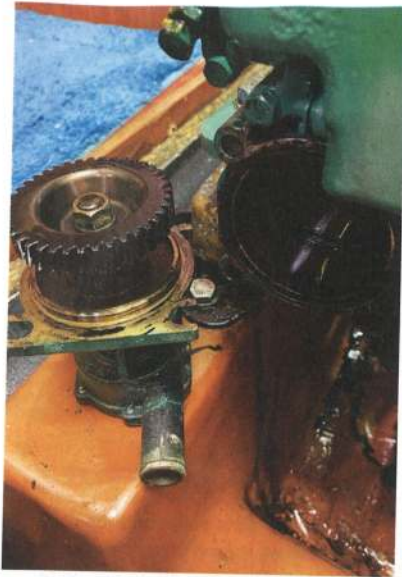
**10** While the raw water pump has nothing to do with a head replacement, as I had full gasket kit I pulled this and replaced the seals, O-rings, and the impeller as part of the engine overhaul.

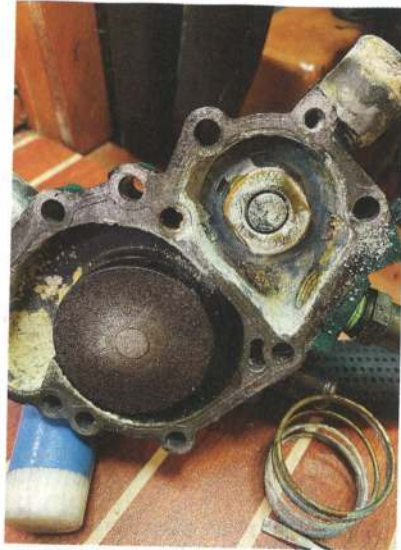
**11** My attention turned to the main water pump and thermostat. It would be difficult to change the thermostat at a later date because the rear bolt is obscured by the heat exchanger when everything is in place, so now was the ideal time for an overhaul.

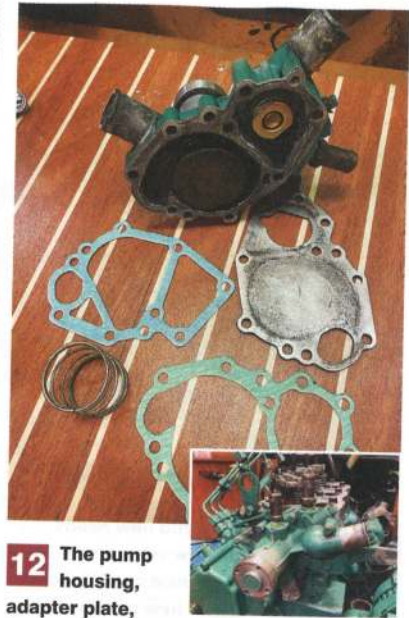
**12** The pump housing, adapter plate, hose connections etc were all carefully cleaned, a new thermostat installed, and the pump refitted with new gaskets. The bolts were all cleaned and greased before being put back.

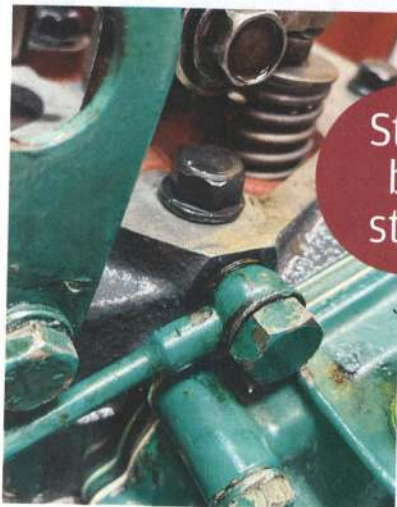
**13** The oil pipe which feeds the head with oil was then refitted, ensuring the copper washers were on the front and back of the banjo bolt.

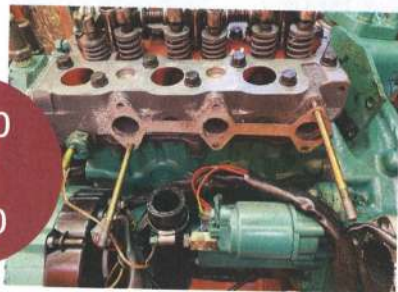
**14** Before installing the heat exchanger, the wire for the water temperature sender was connected, and the larger of the two new cooling water pipes loosely installed (my old pipes were showing signs of cracking). The two studs used on the rear cylinder were temporarily used to locate the new gasket. The gasket was then given a thin coating of exhaust sealant as I like to ensure a good seal is made and none of the nasty gases escape into the boat.

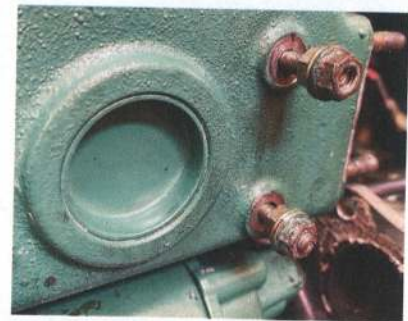
**15** The heat exchanger can then be slid over the studs, and all the bolts fitted after a quick clean and thin application of grease. Opposing nuts were used to tighten the studs on the rear cylinder.

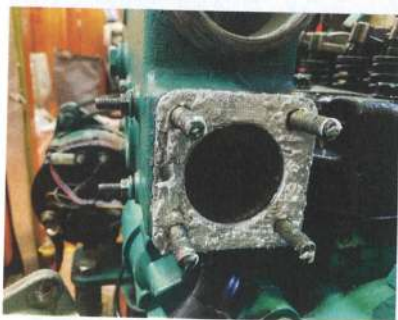
**16** The exhaust elbow then had the old gasket remains cleaned off before I fitted a new gasket with a thin coating of exhaust sealant on both sides to ensure a good seal.

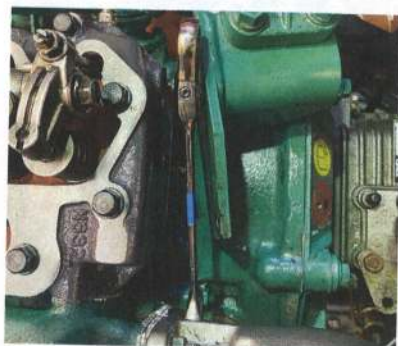
**17** When tightening the elbow is when I realised that having the fuel filter bracket away from the engine body allows easier access to this bottom inboard bolt.

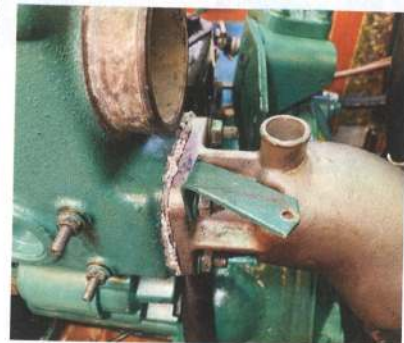
**18** There is also a bracket for the electrical box which needs to be fitted to the top bolt during installation of the exhaust elbow.

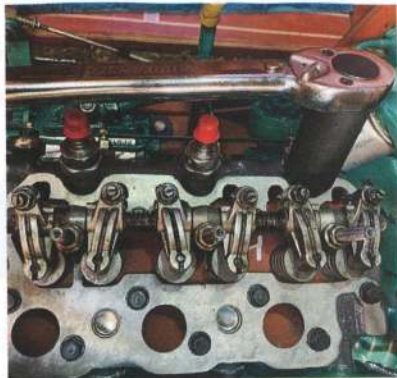
**20** The injectors were then installed and, given they need a significant 85Nm of torque, my bigger torque wrench was pressed into service.

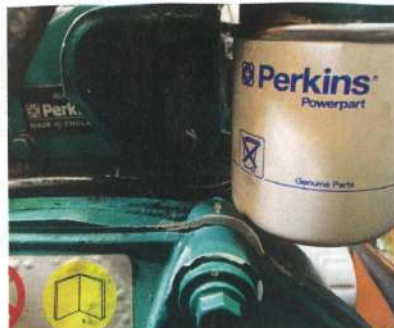
**21** I now reinstalled the fuel filter mounting bracket. Again, in hindsight, removing the filter first would have made locating the inner bolts much easier – especially as I was going to change the filter anyway.

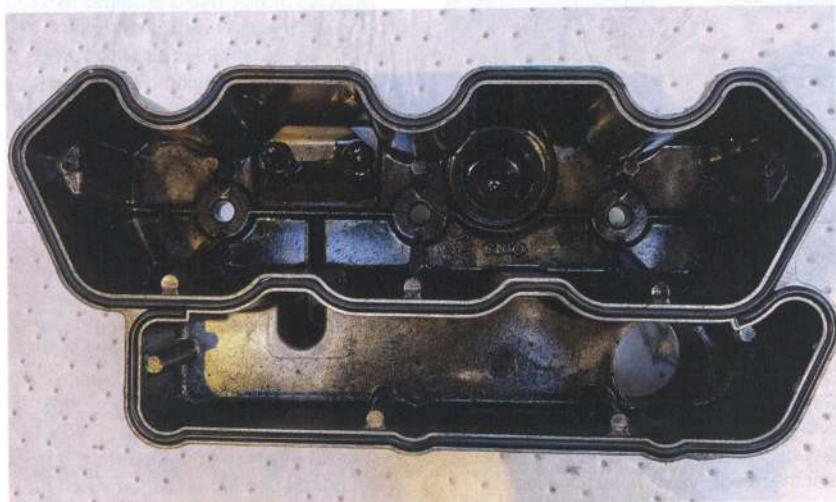
**22** New rubber gaskets were next installed in the valve cover. The larger one is basically like a large O-ring, and care is required when installing as it's easy to stretch it and end up with excess, so it needs to be pushed in vertically. The other piece is a single straight section, and again needs to be pushed in vertically

and not stretched, so I started from the middle and worked my way to each end. There were some signs of some old silicone sealant where the two gaskets meet, so that was cleaned up and I'm hoping the new ones will solve the small weeping oil leaks which I discovered during the dismantling process.

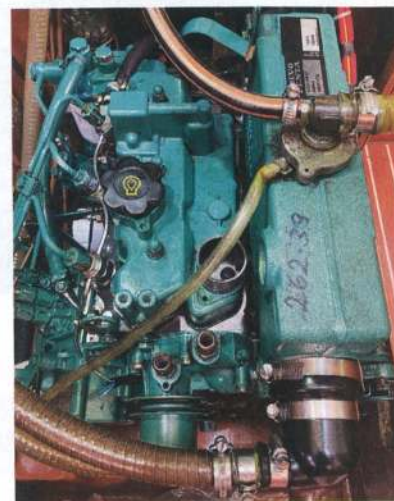
**23** With the valve cover installed, the remaining plumbing was refitted. In addition to the new cooling pipes, I also installed new heat exchanger end caps and clamps working on the theory that if one of them was showing signs of breaking down, the others were probably not far behind.

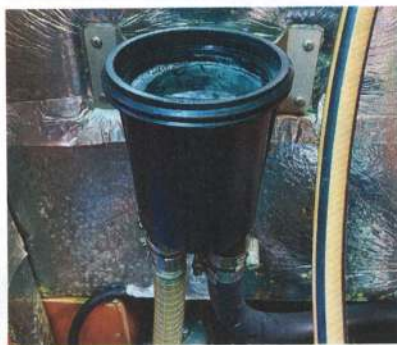
**24** When I fitted the new impeller, it was coated with the supplied grease, however I also always top off the water strainer with the seacock closed as this fills the system with water, so the impeller is never run dry. Once the lid is refitted to the strainer, the sea cock can be opened, and a vacuum prevents the water draining away.

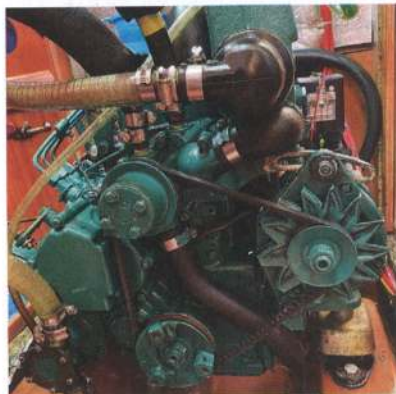
**25** After fitting new oil and fuel filters, refilling with oil and adding fresh coolant, the final steps were to fit the fan belt, tighten the alternator, then reconnect the remaining electrics including glow plugs, oil pressure sender and the main power cables.
