# Spotlight on safety

Huw Williams looks over the safety gear set-up aboard a friend's Jeanneau SO 40 and implements a series of upgrades

A Jeanneau SO 40 similar to the one given a safety audit in this feature

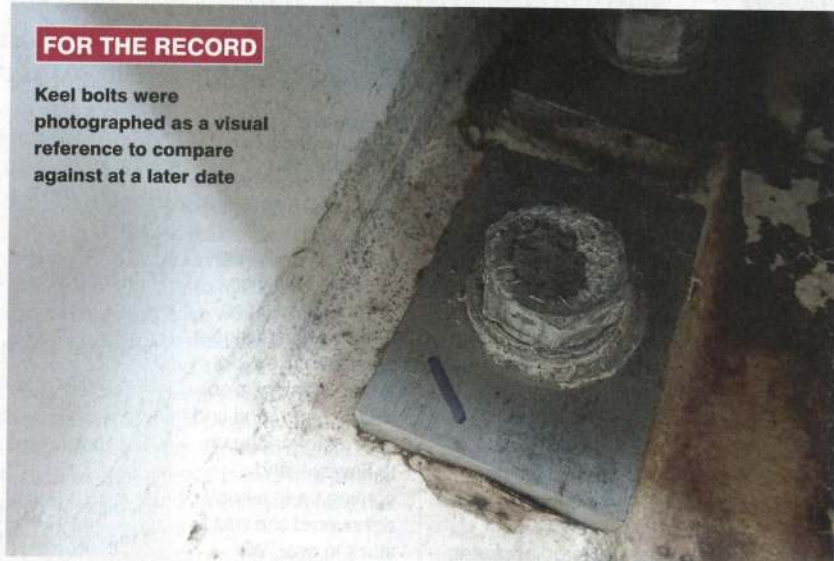
## FOR THE RECORD

Keel bolts were photographed as a visual reference to compare against at a later date

The boat has been surveyed and pronounced sound, but we back this up by photographing the area around the six retaining nuts. Now we have a visual record of any hairline cracks etc. and we can use them as a reference if something like a grounding occurs in the future.

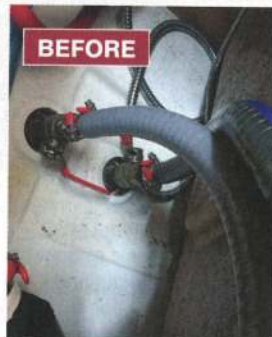
## BEFORE

**ABOVE** Jubilee clips are doubled up but emergency bungs are not in evidence

Thankfully, our Jeanneau SO 40 has metal skin fittings, and each of the hoses is held in place with two stainless steel clamps which inspires confidence. I'm sure they're not likely to fail, but if they do we'll need to react very quickly. There were already a set of timber bungs on board, and some of them were the correct size, but they were stowed under one of the saloon seats. I can imagine the scene trying to find them in an emergency, with the crew tripping over cushions and shouting: 'Where's the mallet?'. And it'll be 3am, of course.

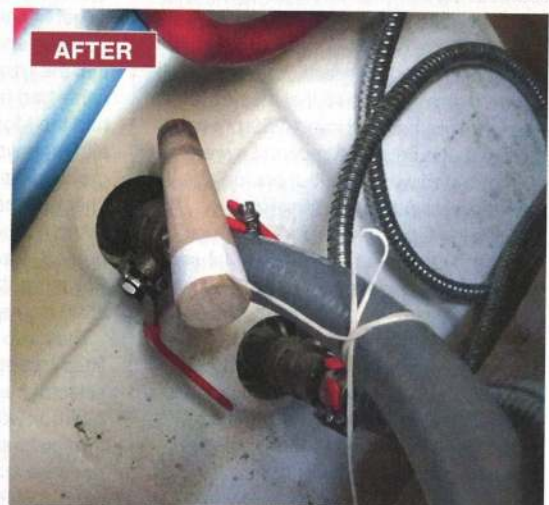
## AFTER

**RIGHT** A bung secured close to a through-hull fitting

Firstly, we worked out which bung matched which fitting. Then we taped each bung to a length of cord and tied this onto the appropriate hose, taking care to prevent them 'tap-tapping' with vibration and driving us crazy. If they're needed, we can just yank them off the cord.

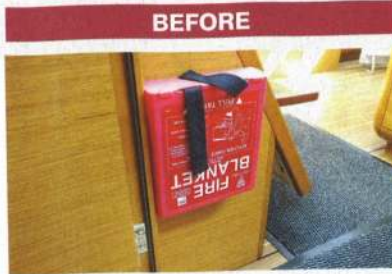
**BEFORE**

**ABOVE** Fire blanket was well positioned

the right place and so we simply applied a luminous strip.

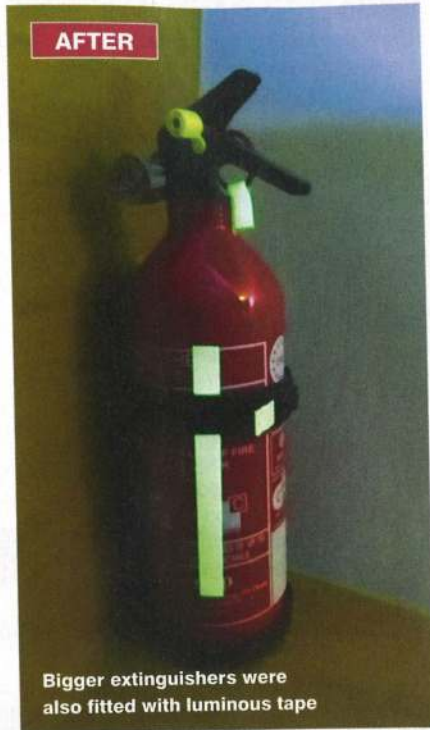
**AFTER**

Bigger extinguishers were also fitted with luminous tape

There were already 0.6kg extinguishers in the forward and rear cabins, all in date and showing green. We resolved to change them for larger models when they got closer to their expiry dates. We fitted a 1kg model in the saloon, and applied luminous tape to the cylinders, ring pulls and retaining straps. The starboard cabin has an access port to the engine bay and this was also highlighted with tape.

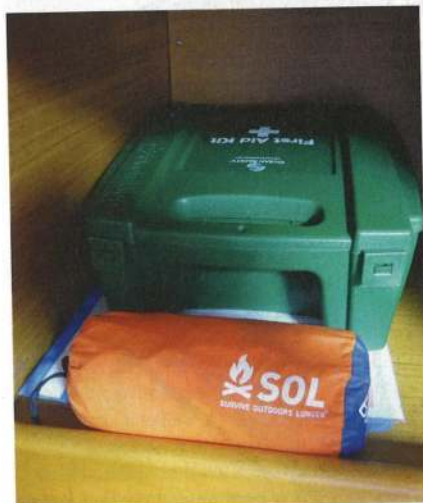
**ABOVE** We upgraded a few items in the First Aid kit and marked the locker with a luminous tape cross

Finally, a small roll of clingfilm was added – it makes a great sterile dressing, particularly for burns. The cupboard was already labelled 'First Aid' and we added a luminous cross.

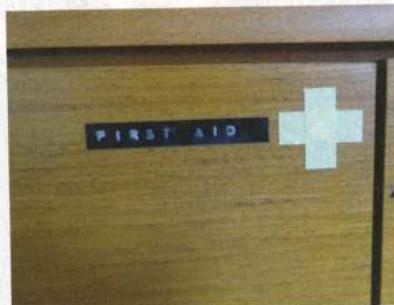
**LEFT** A SOL bivvy bag is for warming up very cold people

The contents were checked, and we added a bottle of saline, sterile tweezers and more pain killers. We also included a list of any allergies and medication relating to the regular crew, a First Aid Manual (left on the saloon table to encourage study) and a SOL Emergency Bivvy Bag. This is like a space blanket, but in a bag shape and is great for warming up cold people. I've used them in the mountains and they work well. Hypothermia, remember, is one of the leading causes of death in boating related fatalities and you shouldn't hesitate to call for assistance if you need it.

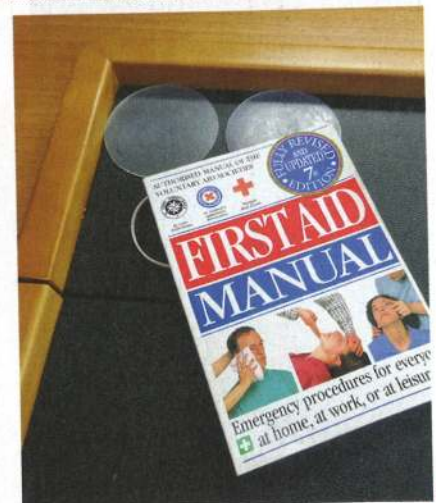
**RIGHT** The First Aid Manual was left out in the saloon to encourage crew to read it

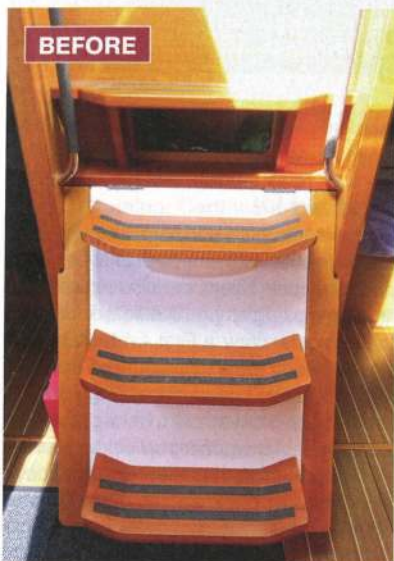
Companionway steps are sensibly fitted with non-slip strips

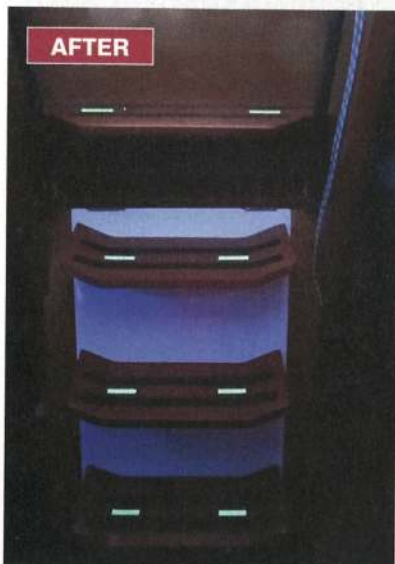
Glow-in-the-dark strips could help prevent accidents in the companionway

There were already grip strips fitted to each step, and we added two short lengths of luminous tape to each step to make things easier at night. We also positioned a small sponge there to inculcate a 'dry steps culture'. Then we climbed up the dry steps to the cockpit...

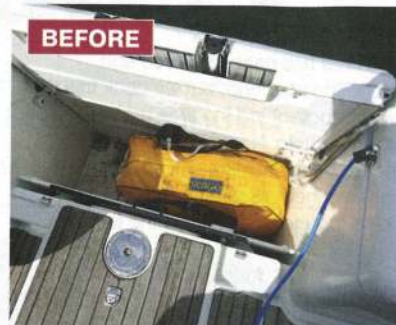
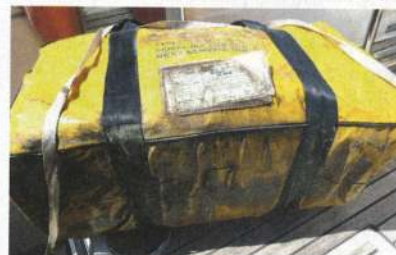
The liferaft was situated in this admirably uncluttered lazarette locker, but the drain was blocked so the raft was sitting in water and was out of date, so we sent it for servicing. The locker lid also needed attention so it could be fully removed to extract the liferaft

Firstly, we hauled out the liferaft, or rather tried to because it's quite a snug fit and to access it you must remove the lazarette lid and the two catches were found to be firmly seized! WD40 penetrating fluid was applied and a few minutes later the lid was off. Then we removed the salt deposits from the catches and applied a layer of grease – smooth operation was restored and confidence in a rapid abandonment increased. When we hauled the liferaft out of the locker it was found to be six months out of date and it had also been sitting in water (the lazarette's drainage hole was blocked) so was looking rather the worse for wear. It was sent for servicing.

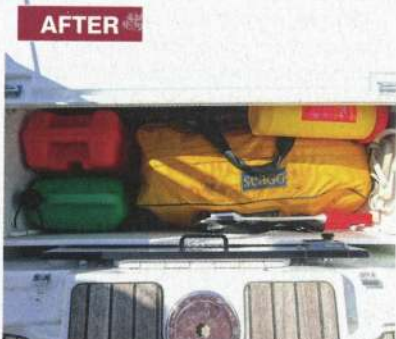
We eventually had to stow the dinghy fuel tanks in with the liferaft as the other cockpit locker wasn't fitted with drains

We also acquired an offshore flare pack which we were planning to put in the lazarette also, but simultaneously discovered the other cockpit lockers had no drainage or venting so we had to store the fuel cans for the new tender's motor next to the liferaft instead.

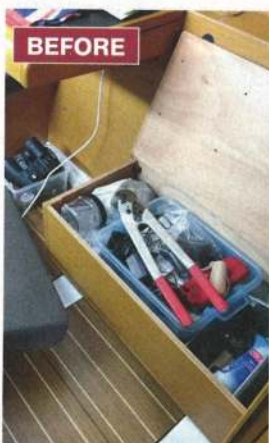
Bolt cutters were stowed in a locker in the saloon – too far from the deck where they'll be needed

Bolt cutters and a soon-to-be-out-of-date coastal flare pack were found in separate locations in the saloon, given a wrap of luminous tape and then placed in the lazarette for quick accessibility.

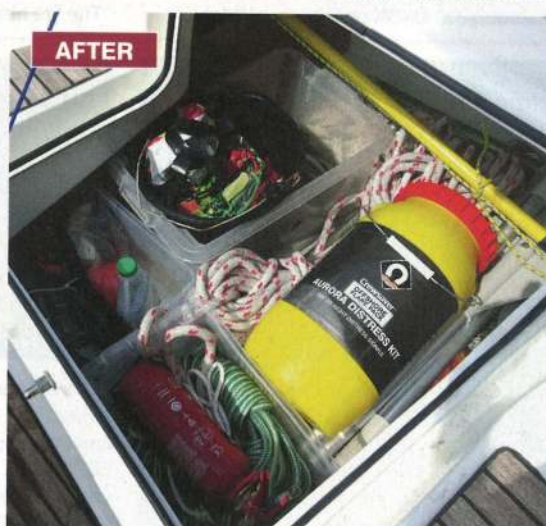
Bolt cutters are now found in a reorganised cockpit locker

purge and the remaining gear was stored in plastic crates. The new offshore flare pack was stored here also.

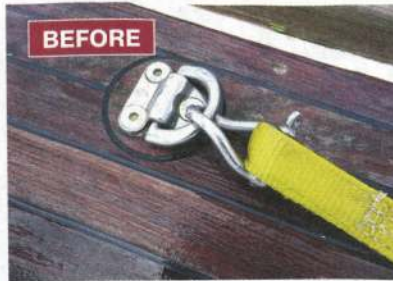
**BEFORE**

**ABOVE** Jackstays were fitted and in good condition but the shackles were not wired... that was simply remedied (right) with plastic cable ties

There was a padeye at the front of the cockpit next to the companionway, but no clip on point for the helmsman so another padeye was fitted between the wheels. There were already jack lines fitted and these were deemed to be sound, but the shackle pins weren't wired and we attended to this.

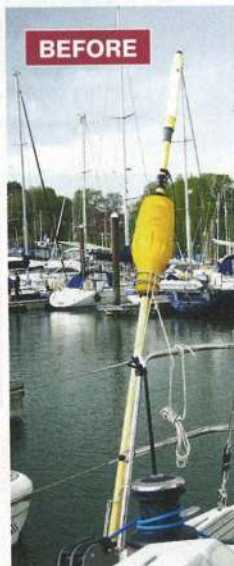
**BEFORE**

The existing set-up was stored in unextended mode, outboard on the starboard side of the pushpit. The flag clip had been replaced with a length of plastic tube (tethered to the back stay) and the longish drogue line (minus the drogue) was tied on to the pushpit as a tether. To deploy it, you must stand on the helm seat (trying not to fall over the lifelines), pull the plastic tube off the flag, unroll the flag, extend and lock in place the three sections, untie the tether line from the pushpit and lob it over the side.

This took 40 seconds in the marina. I wouldn't want to do it in a blow, and certainly not on port tack.

**FAR LEFT** Danbuoy would not have been nice to deploy on port tack!

A revamp was required. Firstly, we moved the holder inboard to a more central position next to the stern gate and mounted it as low as possible.

Then we extended the sections and found them to be slippery with green mould – delightful. We gave them a clean, locked them in place and taped the joints to prevent them working loose. Then we pleated (not rolled) the flag and held it in place with the tube. The long tether line (guaranteed to foul the prop) was removed and replaced with a short length of line and a clip.

To deploy, you pull down the tube (it stays on the pole), unclip the tether and over it goes. Aesthetically, the new set-up looks a little top heavy, but the new deployment time is under five seconds and that's more important

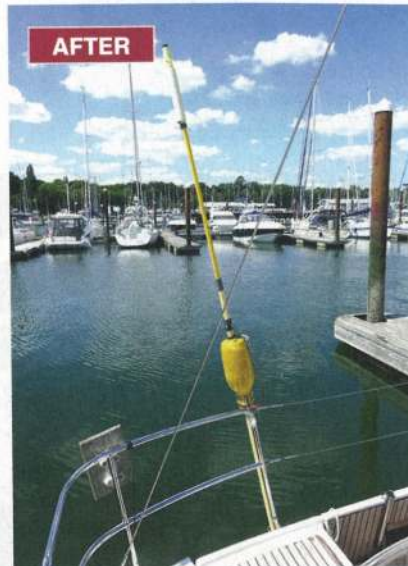
**AFTER**

**LEFT** More centrally located and deployment simplified

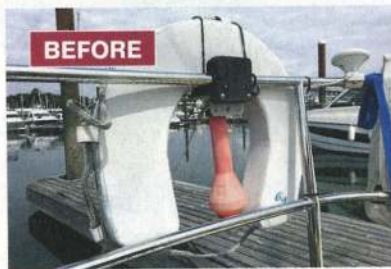
**BEFORE**

The original-equipment horseshoe was suffering from UV degradation and the attached light was found to be full of water, so a new model fitted with an LED light was installed.

The white horseshoe lifebuoy was replaced with a more obviously visible yellow one

We chose a yellow model which doesn't blend in with the boat... or the ocean.

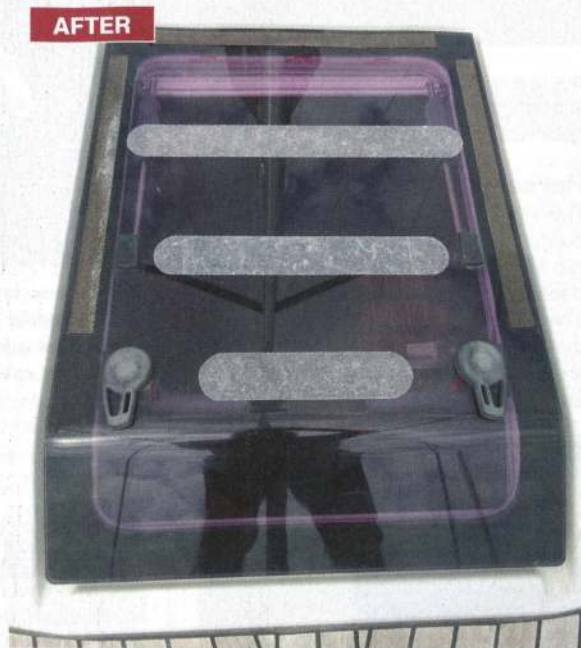
AFTER

ABOVE Some non-slip is needed on this hatch  
RIGHT That's better

None of the deck hatches had grip strips fitted, so we rectified the situation with several self-adhesive strips per hatch (radiused ends of course). When we unzip the sail bag we stand on the sliding hatch over the companionway, so we did the same here.

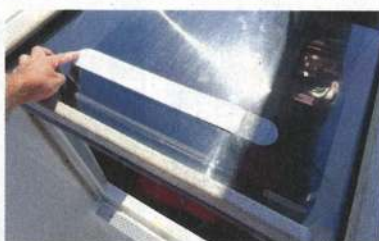
LEFT Hatch over the companionway is regularly used when stowing the mainsail, so it got the non-slip treatment

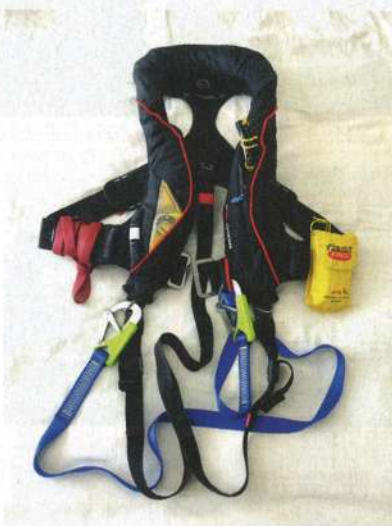
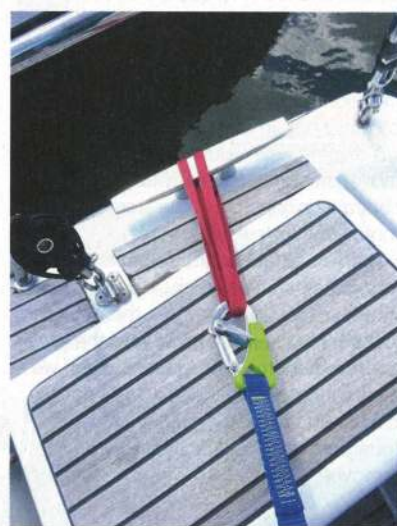
A lifejacket should carry a knife and include a 60cm climbing sling on the waist

belt for occasional tethering on deck (shown above)

The importance of crotch straps, hoods, lights and tethers have been covered over and over again in the pages of PBO, but put a knife in the pocket and make sure it has a lanyard. I also keep a 60cm climbing sling on the waist belt, which is a useful aid in clipping on to parts of the boat that don't have convenient pad eyes or jack lines. Most importantly, as the RNLI tells us, a lifejacket is useless unless worn – so just wear it.
