Refurbishing the alternator

James Wood removes *Maximus's* alternator and gets it repaired

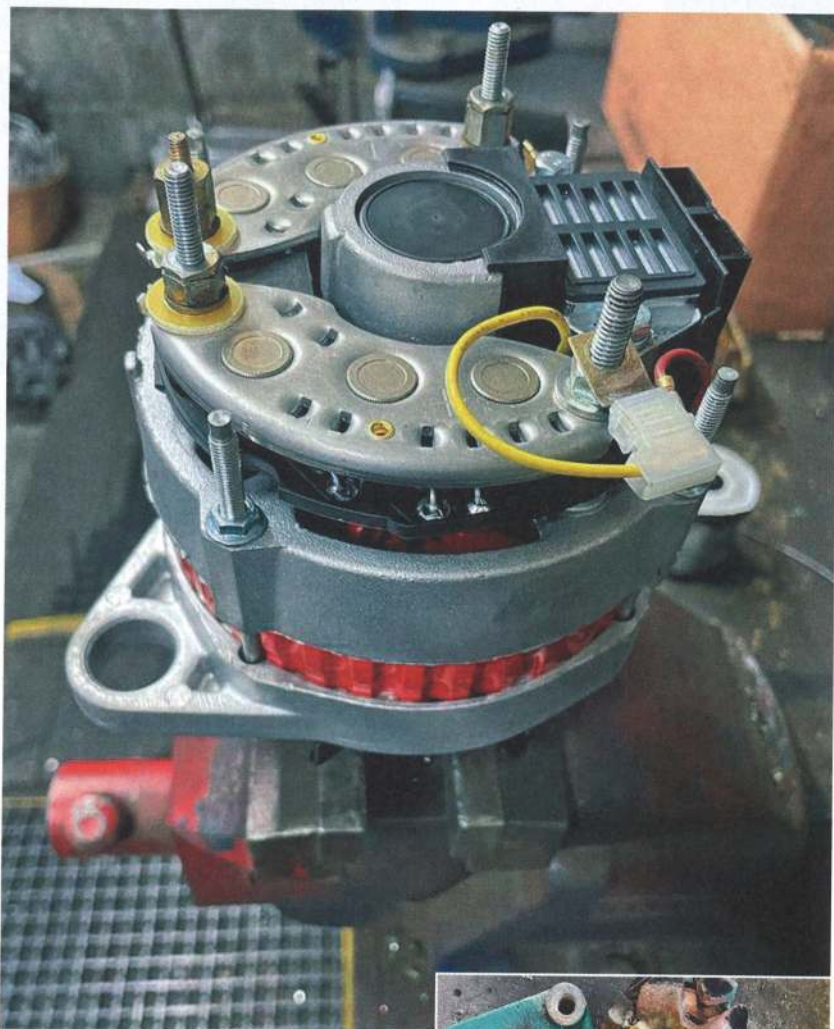
ABOVE Refurbished components reassembled into an alternator
RIGHT The old alternator stripped down

After dropping off the alternator, Alan fully refurbished it and confirmed that the regulator was at fault, replacing it with a new one. The regulator was then finished with Motip Heat Resistant Lacquer to improve its longevity in the damp confines of a boat.

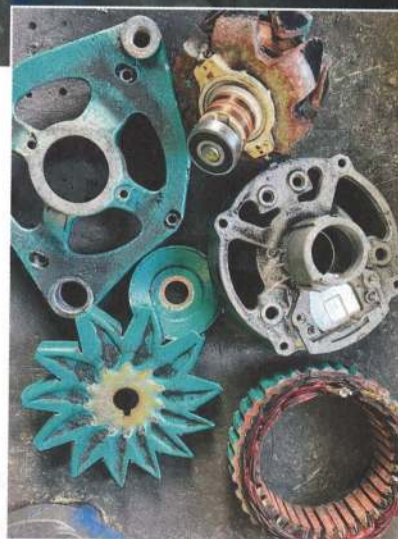
'Removing the diode bridge is more complicated as you'll need a soldering iron'

soldering iron to disconnect the three connecting wires to remove it from the body of the alternator. That done, I tested the inner core and diode connections with the multimeter, with a little assistance from Tino G's Sailing channel on YouTube.

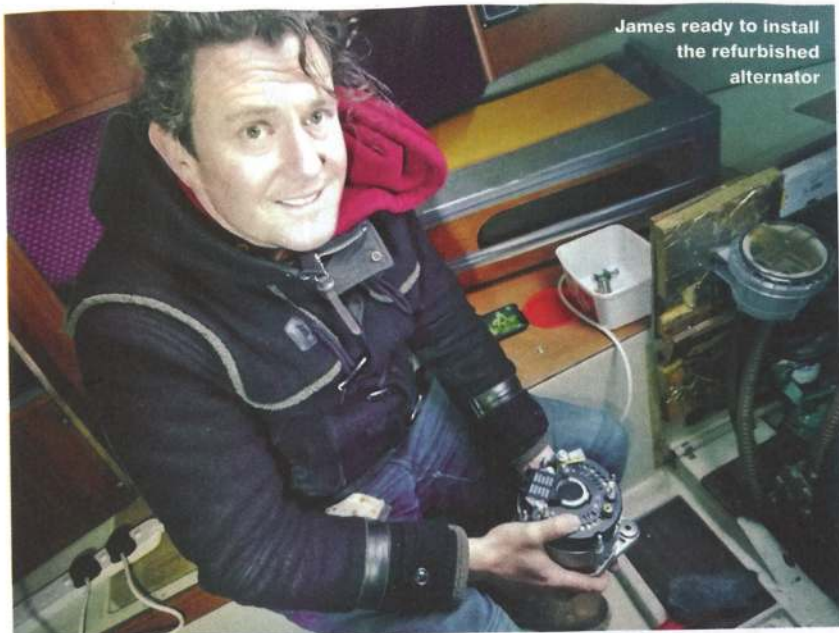
James ready to install the refurbished alternator

I had it back within a week and, together with Ali, set about reinstalling it on *Maximus's* Volvo MD2020 engine. It had taken so long to get it off, could we actually get it back on again? We could hardly see what we were doing and had to reconnect seven different cables in a very tight space. We were glad we'd taken reference photos before removing it initially, so there was a clear guide to getting it back on.

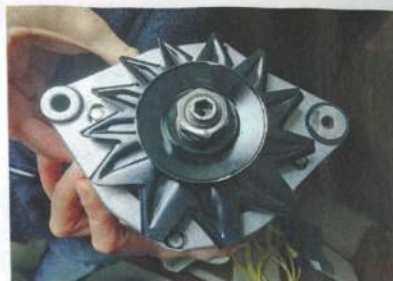
Front view of the refurbished alternator

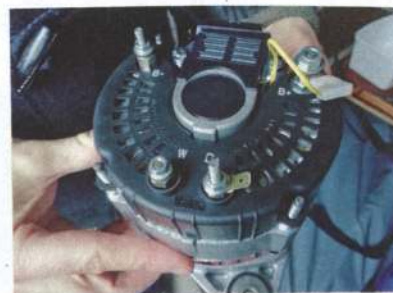
Rear view where all the wiring goes

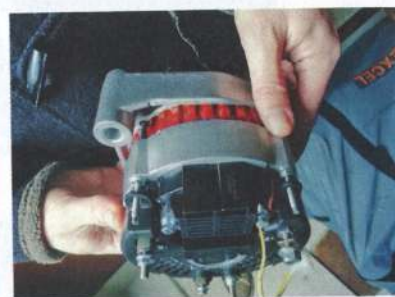
Wiring terminals at the back disappear from view once installed

With help from Ali to replace the alternator, I could then re-attach the cables to the correct terminals. Ali then tightened the bolts, using the handle of a hammer as a lever to tension the V-belt, and we were finished. Now it was time to see if it worked...

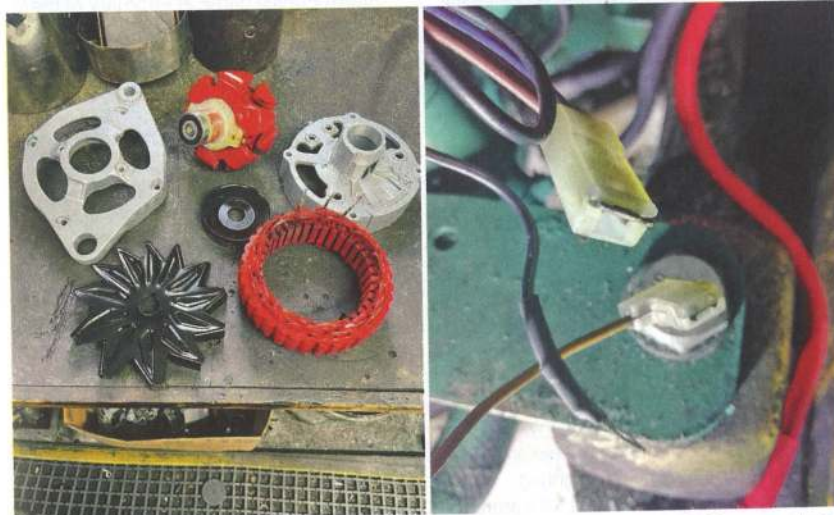
One of the reasons the working space was so tight, which we hadn't realised earlier, was that Adam had cable-tied up all the alternator cables to keep them neat and tidy. I snipped these free, which gave a little more flexibility to the cables. While inspecting them, I noticed that the spade connector for the engine instruments was badly corroded and had completely snapped when it was removed a week earlier. I think this connector probably played a part in the alternator failing, but I'd ordered some new spade connectors and replaced both, so we should

LEFT The alternator's refurbished components RIGHT Spade connector had snapped off
