# Replacing a cylinder head and servicing injectors

Geoff Higginbottom rebuilds his engine with a new cylinder head while Stu Davies demonstrates a DIY injector service

**PART  
2**

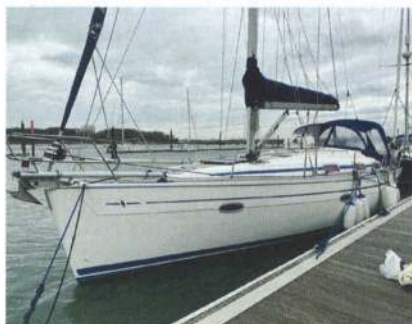
LEFT Geoff's Bavaria 39 Tessa Jane ABOVE RIGHT The precombustion chamber insert on the left cylinder has completely disappeared
